EVALUATION OF CAMISEA PROJECT PIPING FAILURES AND LONG-TERM SOLUTIONS

February 27, 2006

Prepared for:
E-Tech International

Prepared by:
Carlos Salazar Tirado

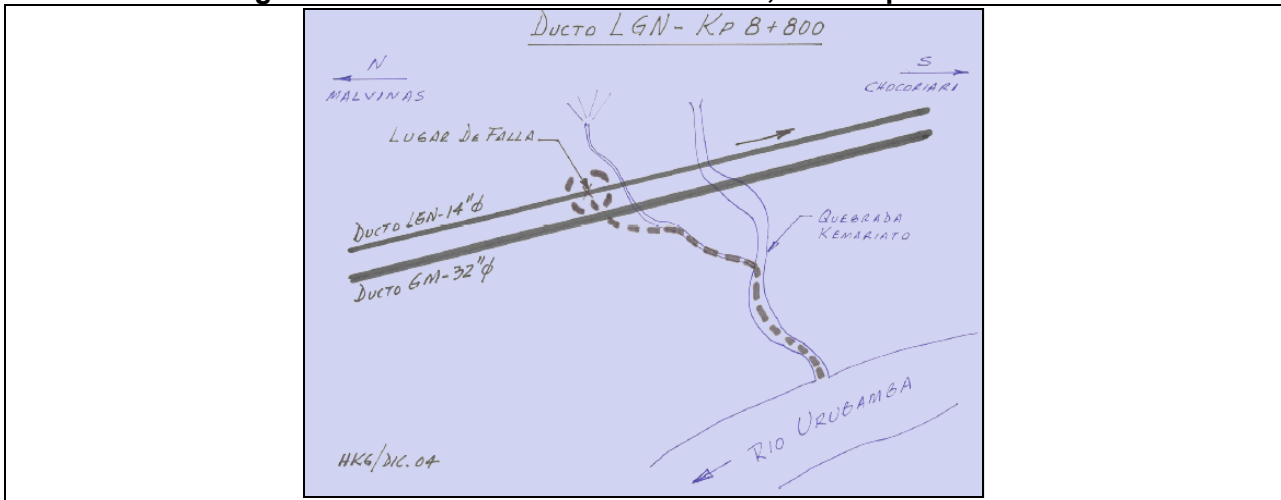
Figure 5. Location of the December 22, 2004 Pipeline Break

December 22, 2004 rupture. The break took place at km. 8.8 in a 14-inch section of the NGL pipeline. This rupture occurred after only five months of operation. The spill dumped hydrocarbons into the Kemariato Gorge and Rio Urubamba-Malvinas. A sketch of the location of the rupture is shown in Figure 5. The quantity of liquids spilled, 183 cubic meters, is identified in the sketch provided in Figure 6. These two sketches come from the OSINERG report on the incident (Attachment 9). DIGESA also prepared a brief analysis of the incident which is included in Attachment 9 as well. The site of the break is identified on a topographic vicinity map in Attachment 10.

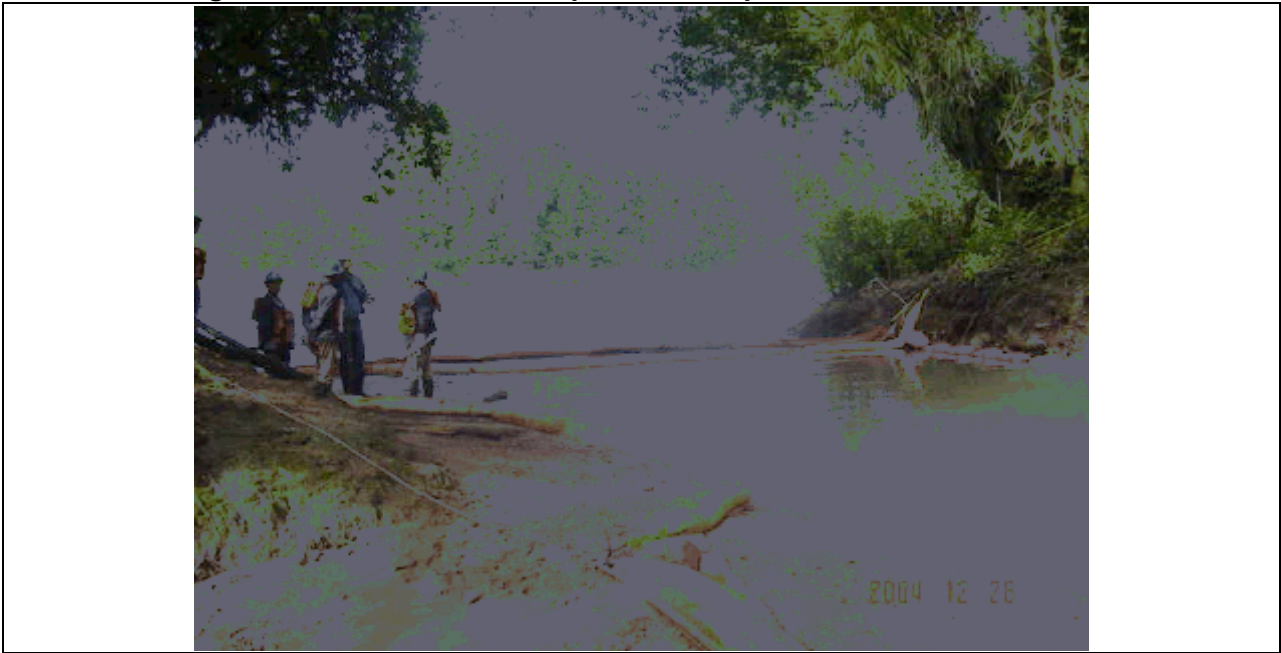
Figure 7. Containment of Liquids After Spill on December 22, 2004

This rupture took place in a gorge that made the process of welding very difficult. The rupture was due to poorly executed and complicated pipe unions and landslides caused by heavy rains. A photo of the containment of in the stream adjacent to the spill is shown in Figure 7. Figure 8 shows site remediation underway following the spill. The amount of soil contaminated by the spill was approximately 300 cubic meters. These photos are from the OSINERG report on this incident (Attachment 9).

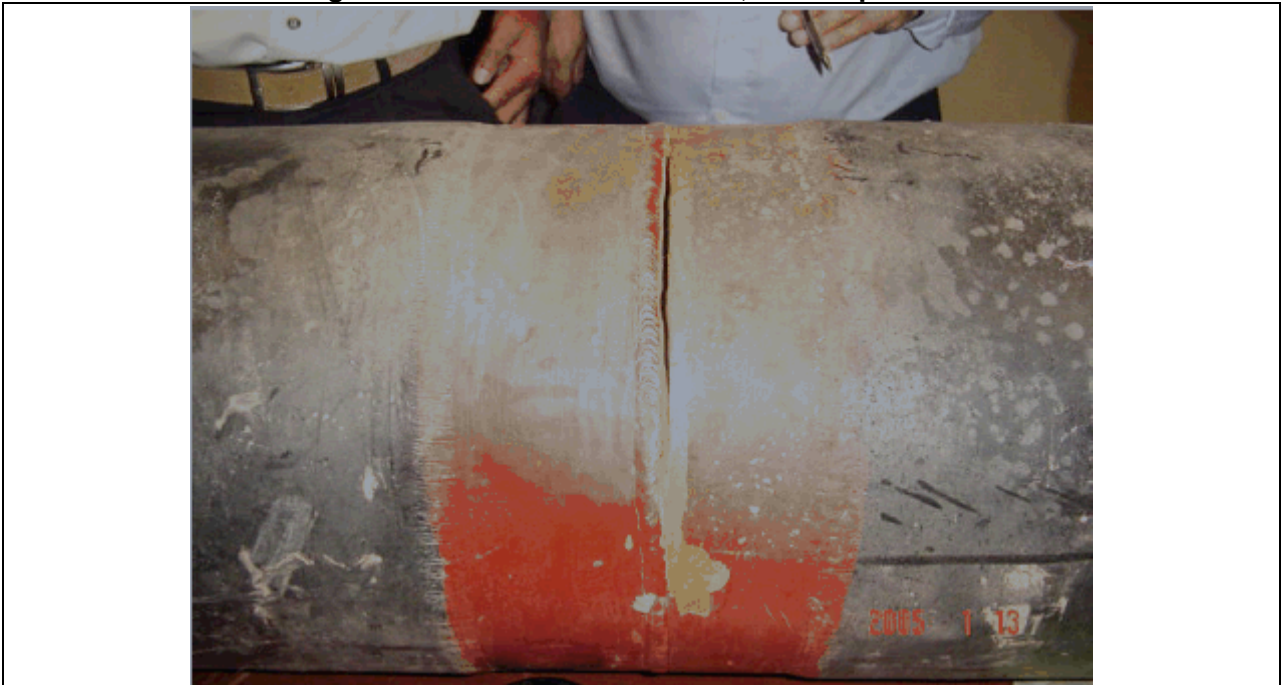
Figure 9. Photo of December 22, 2004 Pipe Break

The pipe rupture is located on the “zag” portion of the weld. A close-up photo of the break is shown in Figure 9.

Probable construction errors contributing to the pipe failure include:

- Inadequate preparation of bevels;
- In the case of a joint or Ti-Im (Ti-Im are pipe unions that are welded or connected over small rivers, gorges, or areas with limited geographic issues) the welding process may not have produced the heat necessary to ensure a quality weld;

- Inadequate handling of the pipes being welded due to strong pressure being applied to maintain the pipes in position for welding;
- Pressure overload due to soil displacement or mudslides caused by constant rains in the area;

- The generalized internal corrosion of the pipe is conducive to fissure creation;
- Landslides involve many variables including different types of soil movements, speeds, fault types, materials, and geologic factors;

- When pipe is welded, or when it is transported to the trench by heavy equipment, it is subjected to tension and flexing;
- When rain washes away soils, especially where the pipeline is located, this often causes the pipe to “float,” or lose its bracing. In the case of marsh locations ballast must be added so that the pipes remain in the pipe trench permanently (concrete ballast is one alternative).

- Use smart pig equipment to verify the condition and integrity of the pipeline;
- Use airborne laser optical tracking system;
- Conduct hydrostatic tests;
- Take samples of the collapsed pipe and conduct mechanical tests to determine pipe trustworthiness.

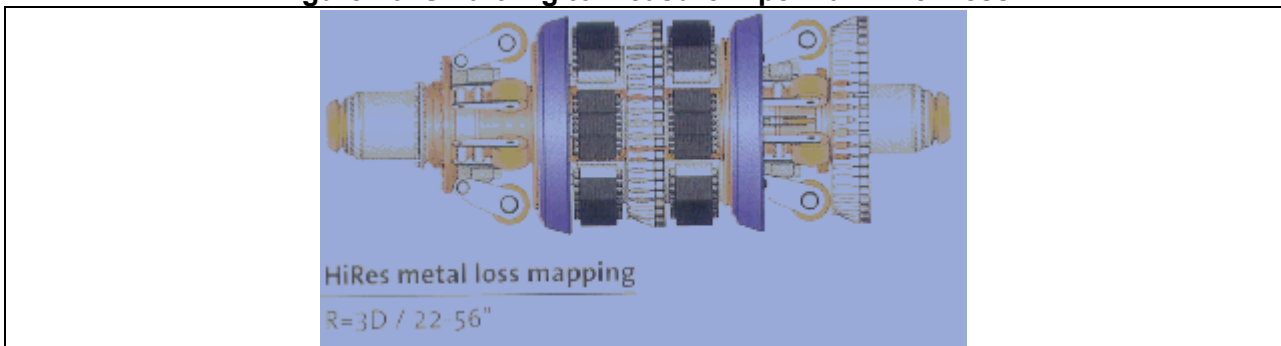
Figure 10. Smart Pig to Measure Pipe Wall Thickness

The use of the Smart Pigs is an alternative to verify the state and integrity of the pipeline. However, this equipment does not conclusively determine the thickness of the pipe. Pipe thickness verification is determined exclusively via ultrasound, that in would determine the degree of internal corrosion and wear. See drawing of a Smart Pig in Figure 10.
